**APPLICATION OF POWDER METALLURGY  
TECHNIQUES TO PRODUCE IMPROVED BEARING  
ELEMENTS FOR LIQUID ROCKET ENGINES**

D. J. MORACZ, ET AL  
COMPRESSOR COMPONENTS TEXTRON  
MATERIALS & MANUFACTURING TECHNOLOGY CENTER  
23555 EUCLID AVENUE  
CLEVELAND, OHIO 44117

**FINAL REPORT**

**AUGUST, 1992**

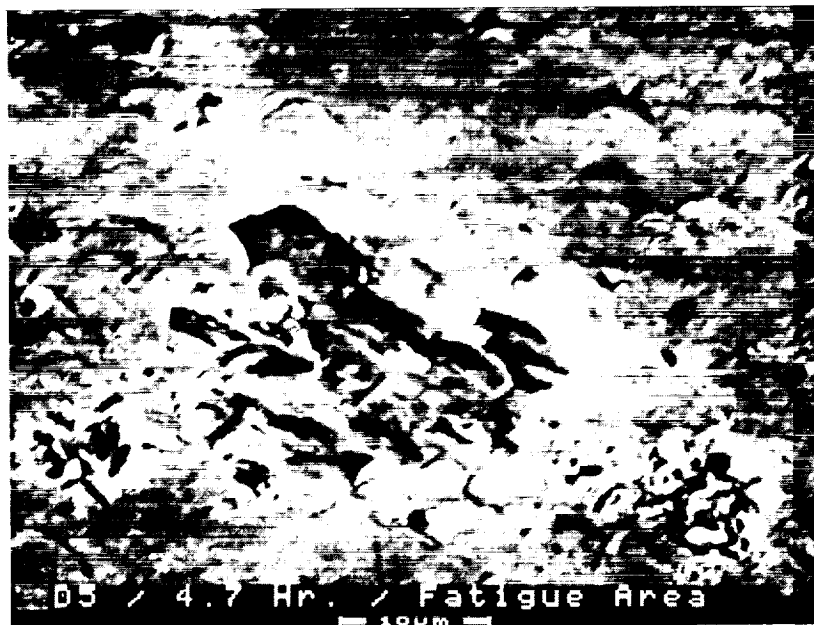
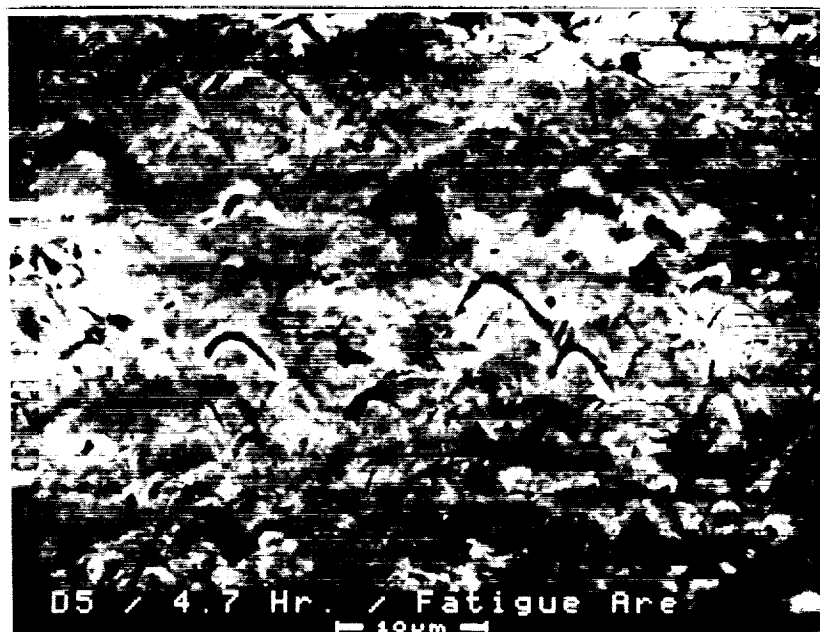
Figure 47. Scanning electron microscope (SEM) image of wear track surface of P/M D-5 alloy ball which failed after 4.7 hours.

(c) Area of Multiple Fatigue Damage Sites (No. 2) at Higher Magnification → 2,000X
